REPORT NO. 3572

ATLANTIC COAST LINE RAILROAD COMPANY

IN RE ACCIDENT

AT BIRMINGHAM, ALA., ON

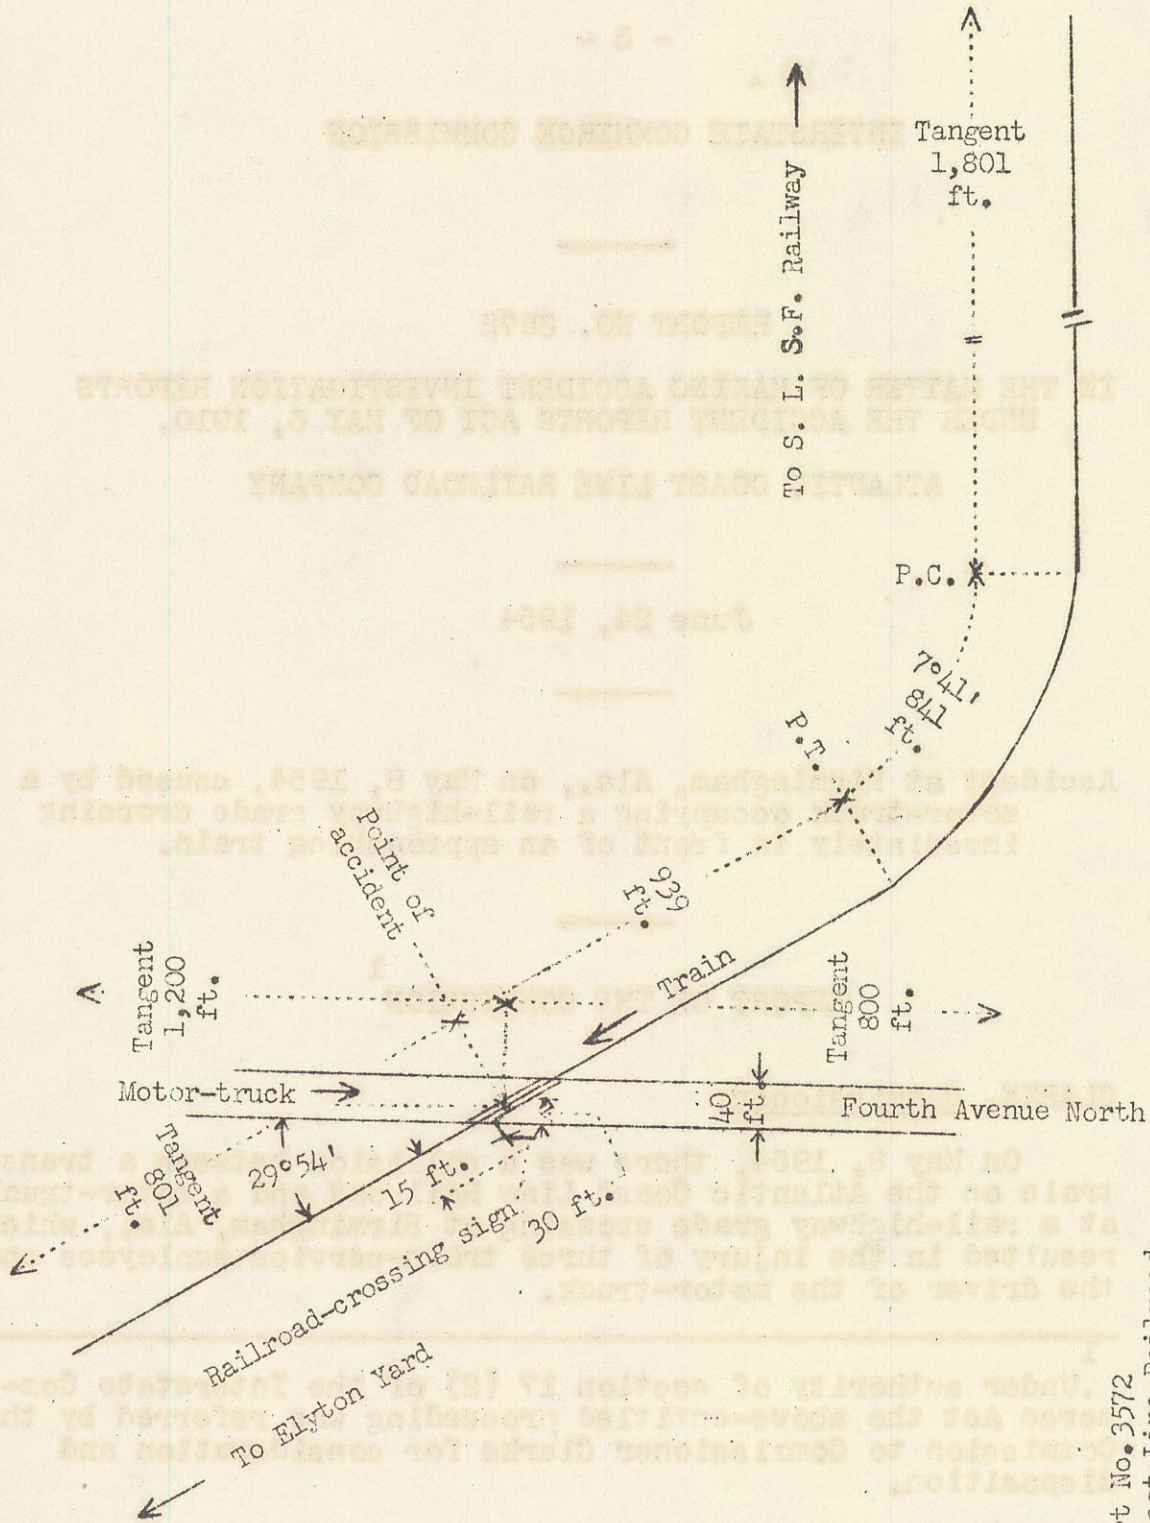
Accident at Birmingham, Ala., on May 8, 1954, caused by a
motor-truck occupying a rail-highway grade crossing
immediately in front of an approaching train.
